Manhole Inspection Summary

Manhole # S47K__019MH

Insp Date: **2/10/09 3:03 PM**

Location Address: **2030 ALICEANNA ST**

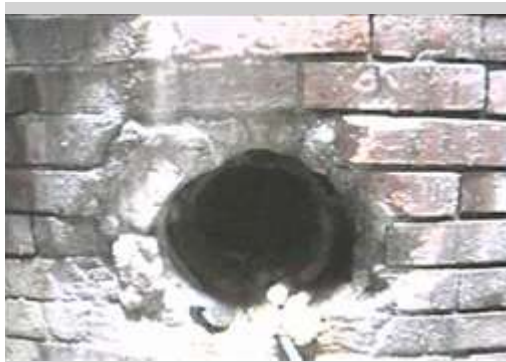
Miscellaneous

DEBRIS AT 3 OCLOCK IN

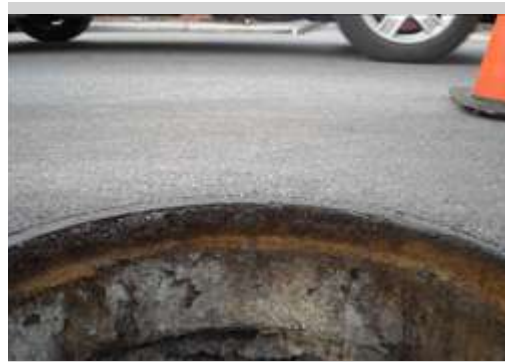
EVIDENCE OF INFLOW DUE TO SHEETING FROM CROWN OF ROADWAY

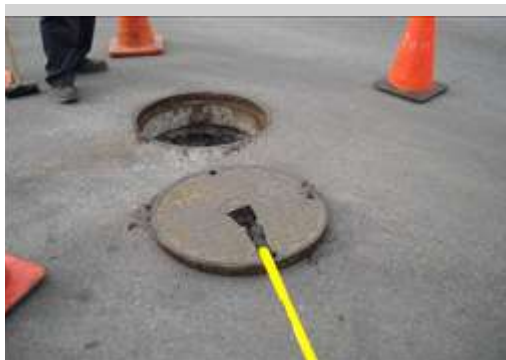
OPENED

USED 16 LB SLEDGE TO BREAK SEAL AND OPEN MANHOLE

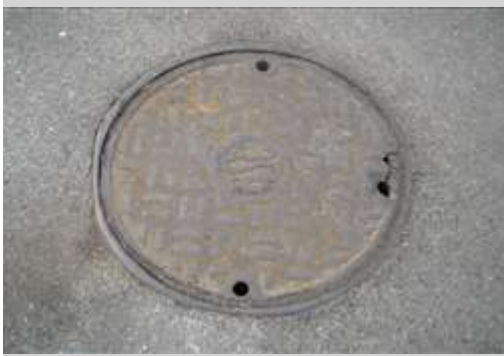
BROKEN LID

LID WAS WORN AND BROKEN ON ARRIVAL

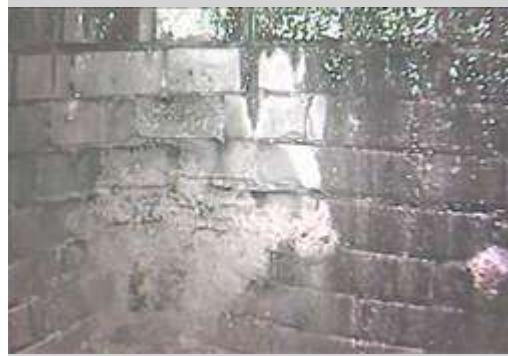
Defect 5

Condition: ☐ Sound ☒ **Cracked** ☐ Root Intrusion ☐ Loose Brick ☒ **Deteriorated**

DETERIORATED CORBEL WALL

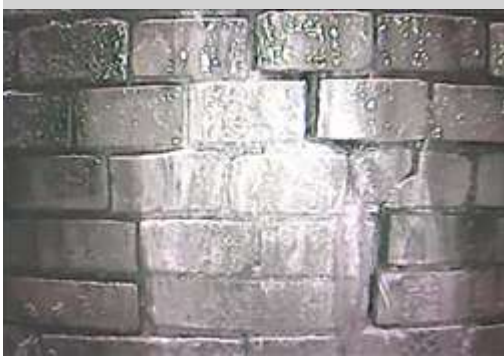
Defect 4

Infiltration: ☐ None ☐ Joint ☒ **Cracks** ☐ Mortar ☐ Roots ☒ **Wall**

ACTIVE INFILTRATION THROUGH CRACKS IN CORBEL WALL ABOVE 6 OCLOCK IN

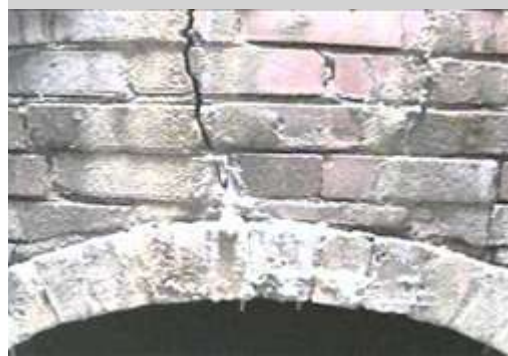
Defect 3

Condition: ☐ Sound ☒ **Cracked** ☐ Root Intrusion ☐ Loose Brick ☒ **Deteriorated**

Infiltration: ☐ None ☒ **Joint** ☒ **Cracks** ☐ Mortar ☐ Roots ☒ **Wall**

BARREL WALL IS CRACKED

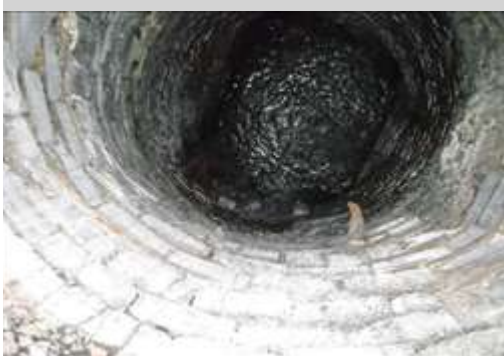
Defect 2

Count: **0** Missing: **7** ☒ **Corroded**

ALL STEPS ARE CORRODED AND MISSING. CANNOT GIVE ACCURATE COUNT OF NUMBER EXPECTED

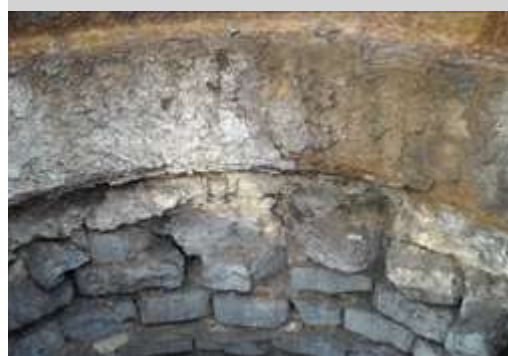
Defect 1

CHIMNEY IS CRACKED AND DETERIORATED WITH A GAP BELOW FRAME

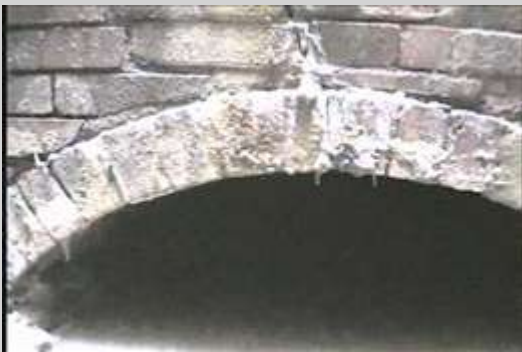
12 O'Clock Outflow

NOTE WATER COMING IN THROUGH SEAL

Infiltration: **Evidence**

Pipe Seal Cond: **Cracked**

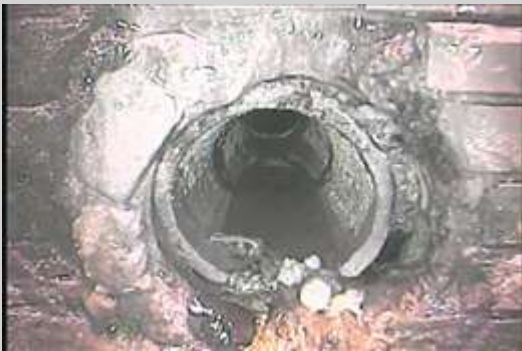
3 O'Clock Inflow

Infiltration: **Evidence**

Pipe Seal Cond: **Broken**

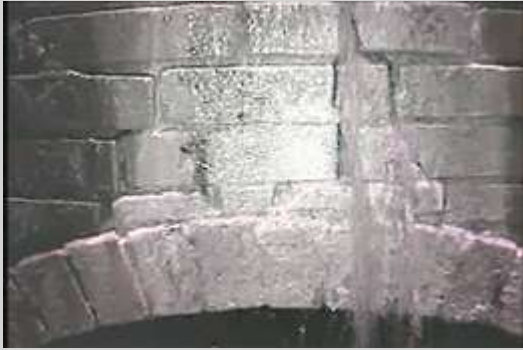
6 O'Clock Inflow

Infiltration: **Gusher** Pipe Seal Cond: **Cracked**
